Flight 587 Rudder Breakup

A Theory of the Breakup Sequence

by Murdo Messer

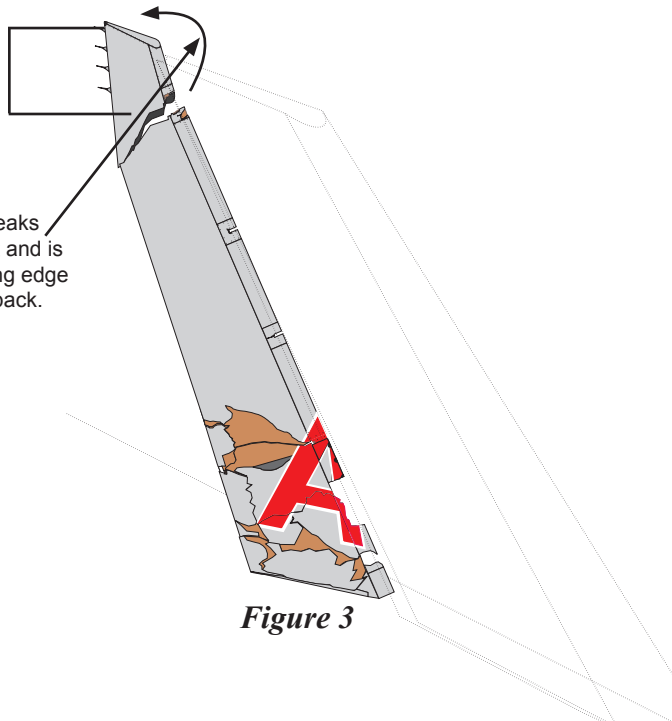
Figure 3

I think that the break-up sequence began at the top of the rudder. The photographs show that one of the major pieces that remains of the rudder came from the top most section. From diagrams it can be seen that there is about 4 feet of rudder above the top most attachment point, hinge 7. I think that, if the force being exerted on the rudder was sufficient, this top portion broke from starboard to port, (*figure 3*), in line with the hinge. The force would be concentrated along this point.

Top of rudder breaks starboard to port and is torn away, leading edge rotating up and back.

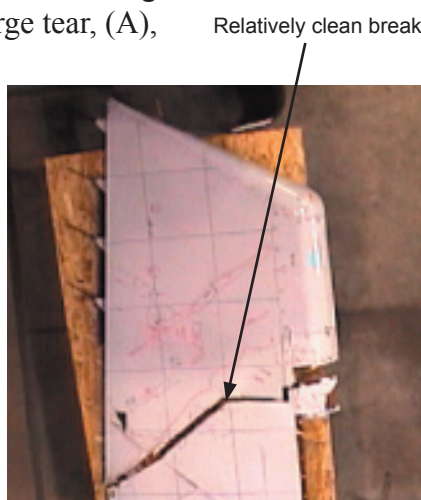
Image 1

The break on the starboard side is very clean, (*image 1*) indicating to me that the pieces here were pulled away from each other. A photo of the port side (*image 2*) of this piece seems to show much more damage which one would expect as the two edges along the break are being compressed together. Also in image 2 the large tear, (A), level with hinge 7 appears to have been created by a force pulling from inside the rudder out or by the top rudder piece twisting or rotating as it broke away. Similar material can be seen still attached to the area around the remains of hinge 7, (*image 3*).

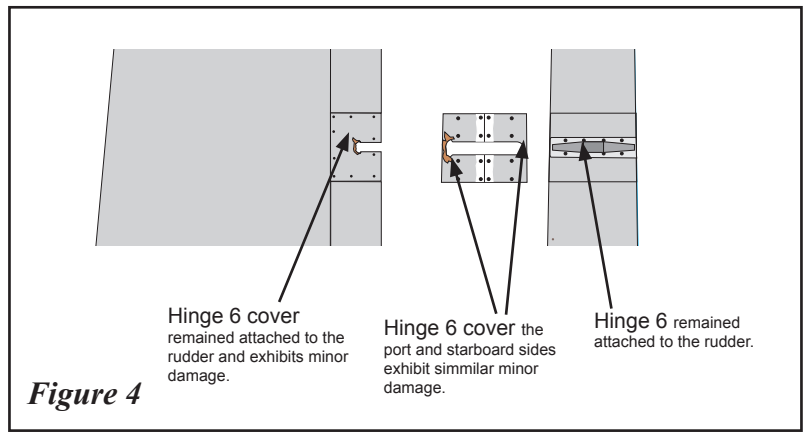
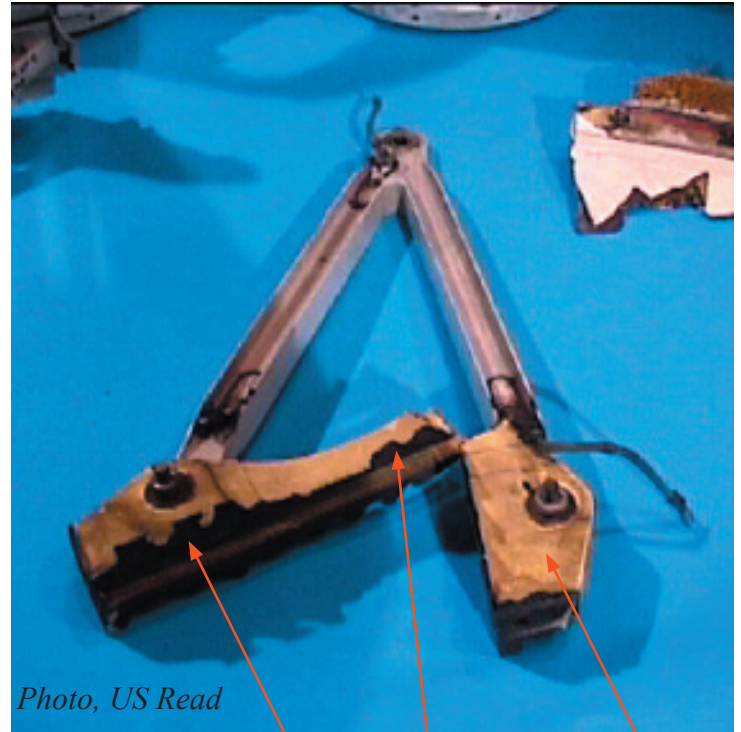
Image 5 Port side Starboard side

The tearing pattern of the laminate material, (image 5), (black in photo) indicates that the hinge separated from the vertical stabilizer in a starboard to port and slightly downward direction. This would be consistent with a force applied to the starboard side of the rudder.

Hinge 6 removed from the rudder shows damage at vertical stabilizer attachment point. The tearing pattern of the laminate (black in photo) material indicates that the hinge seperated from the vertical stabilizer in a starboard to port and slightly downward direction.

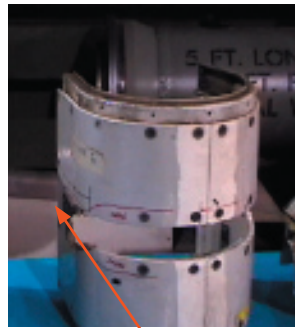
Image 4

Hinge 6 was the only hinge that broke at the vertical stabilizer. There is minor damage on the starboard and port side of the hinge cover, (figure 4, image 4). This damage would indicate that the hinge arms moved freely back and forth beyond their normal operating range suggesting that the damage to the hinge cover occurred after the rudder separated from the vertical stabilizer.

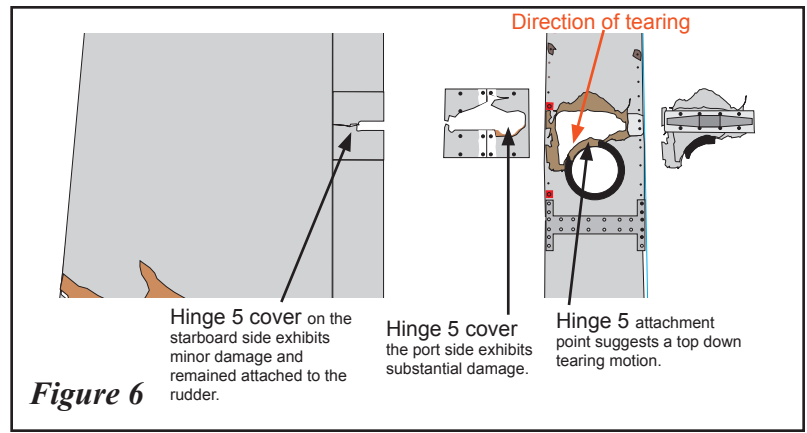
Hinge 5 is the lower hinge of the largest piece of the rudder. The hinge cover (*image 6*) exhibits the same port side damage seen in the actuator hinges. The damage to the hinge (*image 7*) itself and the attachment point seem to imply a top down tearing (*figure 6*), with a port twisting. I think it failed in a downward motion and is pulled through the port side of the hinge cover as the rudder section pivots backwards.

Hinge 5 cover exhibits extensive port side damage.

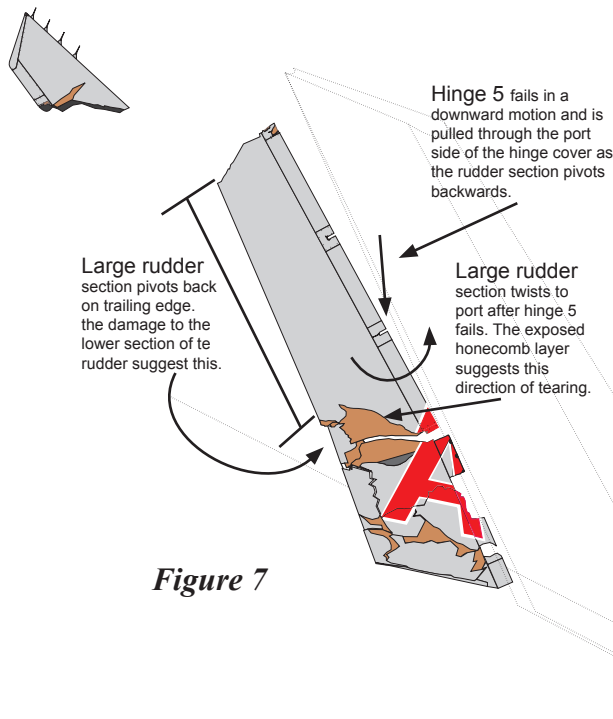
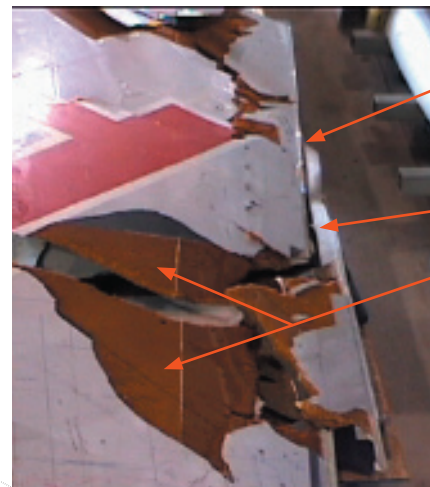
Image 8 Photo, US Read

A top down tearing would seem possible when viewed in light of the damage to the trailing edge near the base of the rudder (*figure 7 & image 8*).

Trailing edge damage suggests the top portion of the rudder section pivots backwards and twists starboard to port. This strip of metal from the port side trailing edge suggests this pattern of failure as does the loss of the laminate layer here.

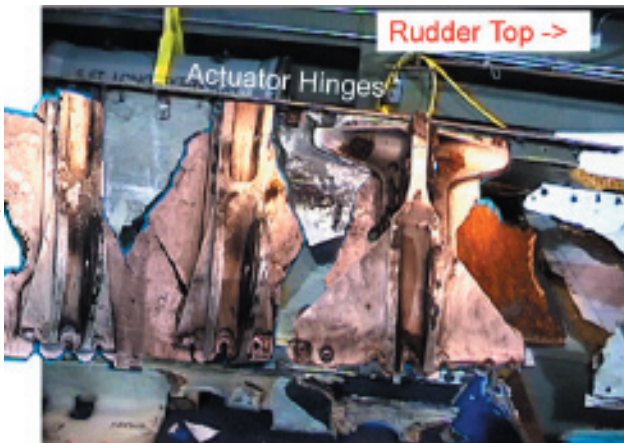
Image 9

The area around the actuator hinges exhibits the most damage to the rudder. The same tearing left to right as seen around hinge 1 can be seen here. Photos of the port side actuator hinge cover shows considerable damage. This would indicate that when the actuator rudder hinges separated they tore through the hinge cover toward the port side.

Area where actuator hinges were torn from the rudder.

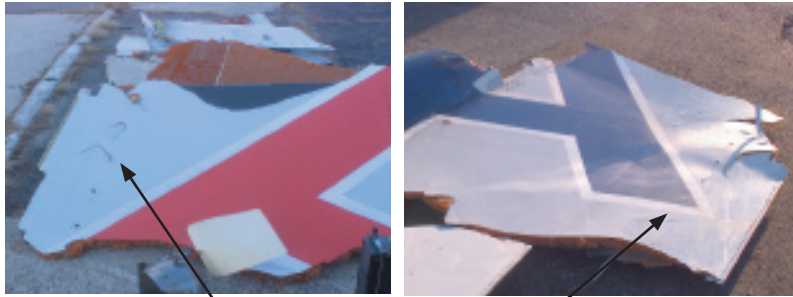
Image 10

It is difficult to determine exactly how the area around the actuators broke, however, given the extent of the damage considerable force must have been exerted upon it. One possible explanation, (figure 10), for the damage is that the area around the actuator hinges is quite wide and hollow, a potentially weak area of the rudder. When the hinges broke away from the rudder and the upper portion of the rudder separated this wide area would have been exposed to the slipstream and quite possibly “blown” apart by the onrushing air. Conversely it is also possible, though I think less likely, that the damage done occurred when the rudder hit the water.

Trailing edge damage suggests that the lower portion of the rudder was pulled apart. The starboard side shows triangular tears pulled inward suggesting that it was pulled away from the port side. The port side of the same area shows the rivets intact

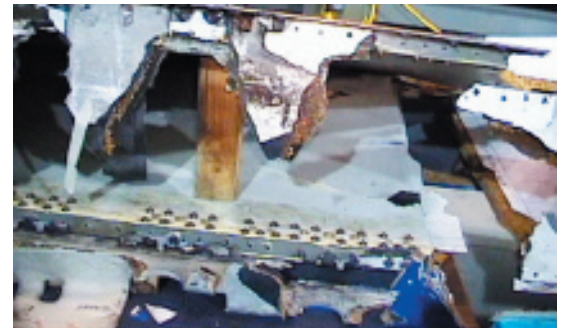
Image 13

Less damage on starboard side

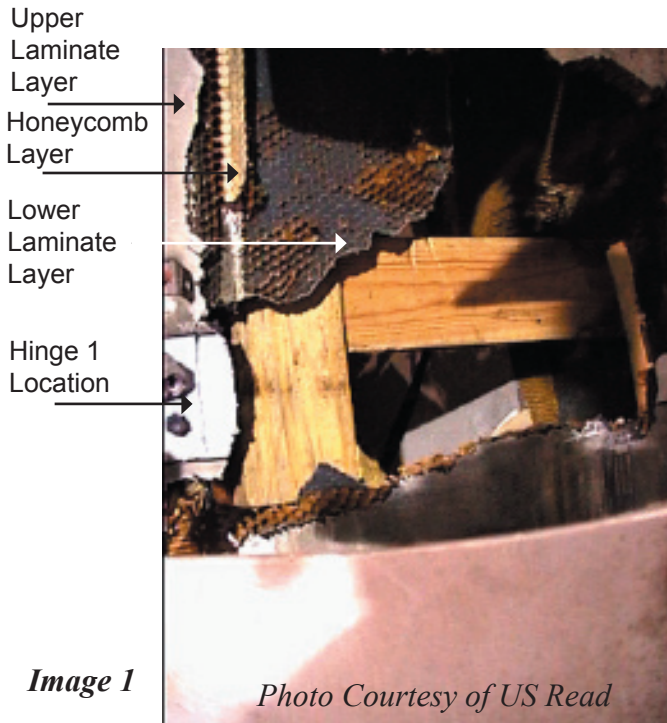
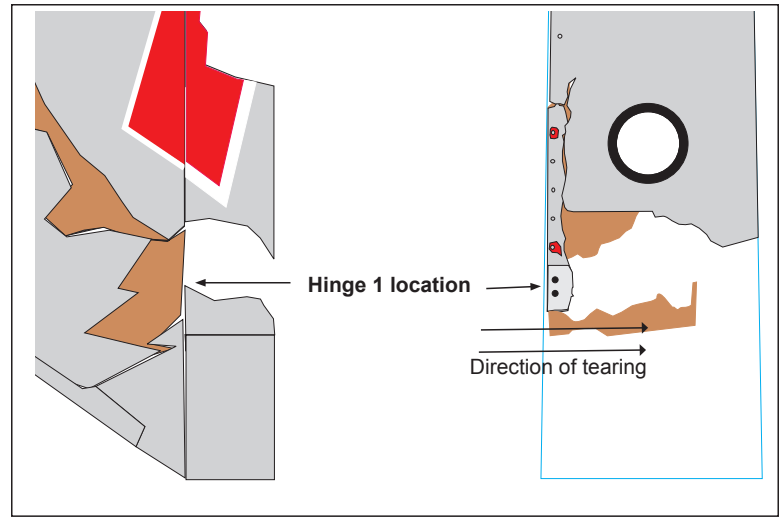
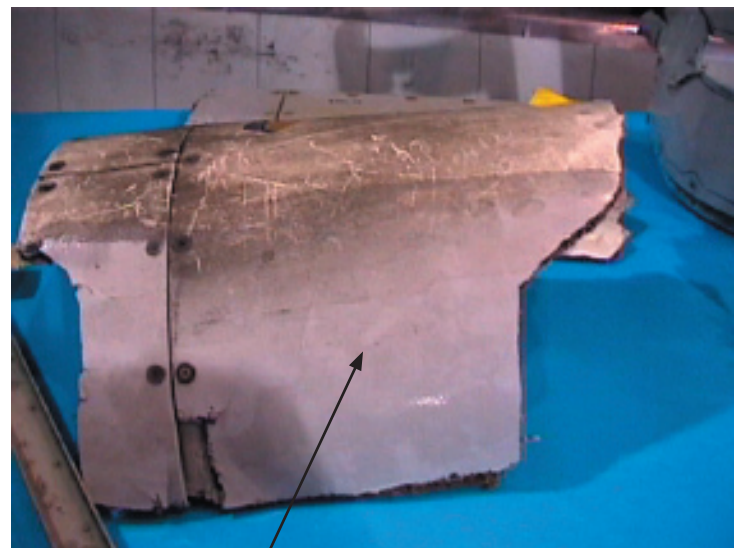
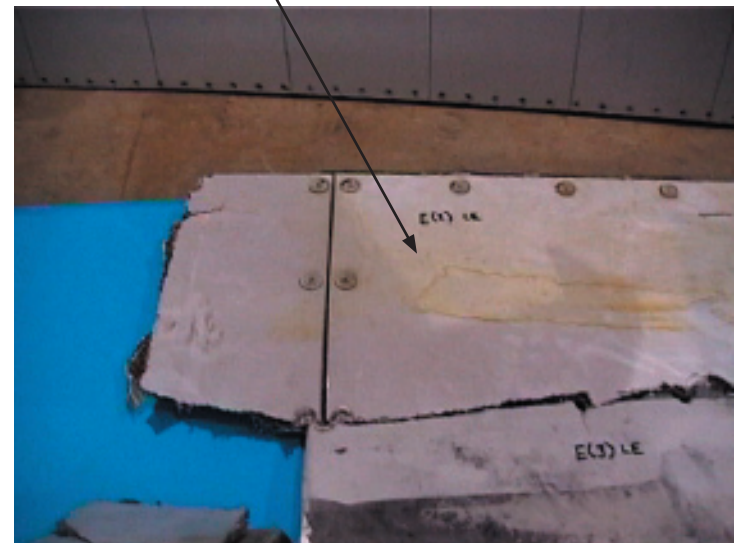
Hinge 1 Cover Pieces

There are not many pictures of hinge 1 available, however from (*image 1*) it can be seen that hinge 1 was torn from the rudder attachment point. My reading of the picture is that the composite material around the hinge broke starting on the left hand side of the photo (starboard side of the rudder) and tore left to right pulling material away. I infer a rightward tearing motion from the layering of the composite material. On the left we see the upper layer of the laminate material (light grey), next the honeycomb layer and then the bottom laminate later.

Though not visible in the picture I would surmise that, like the other attachment points, the tearing continued through to the right side leaving only a little bit of material where the rivets held it to the frame, see (*figure 12*).
