Flight 587 Rudder Breakup

A Theory of the Breakup Sequence

by Murdo Messer

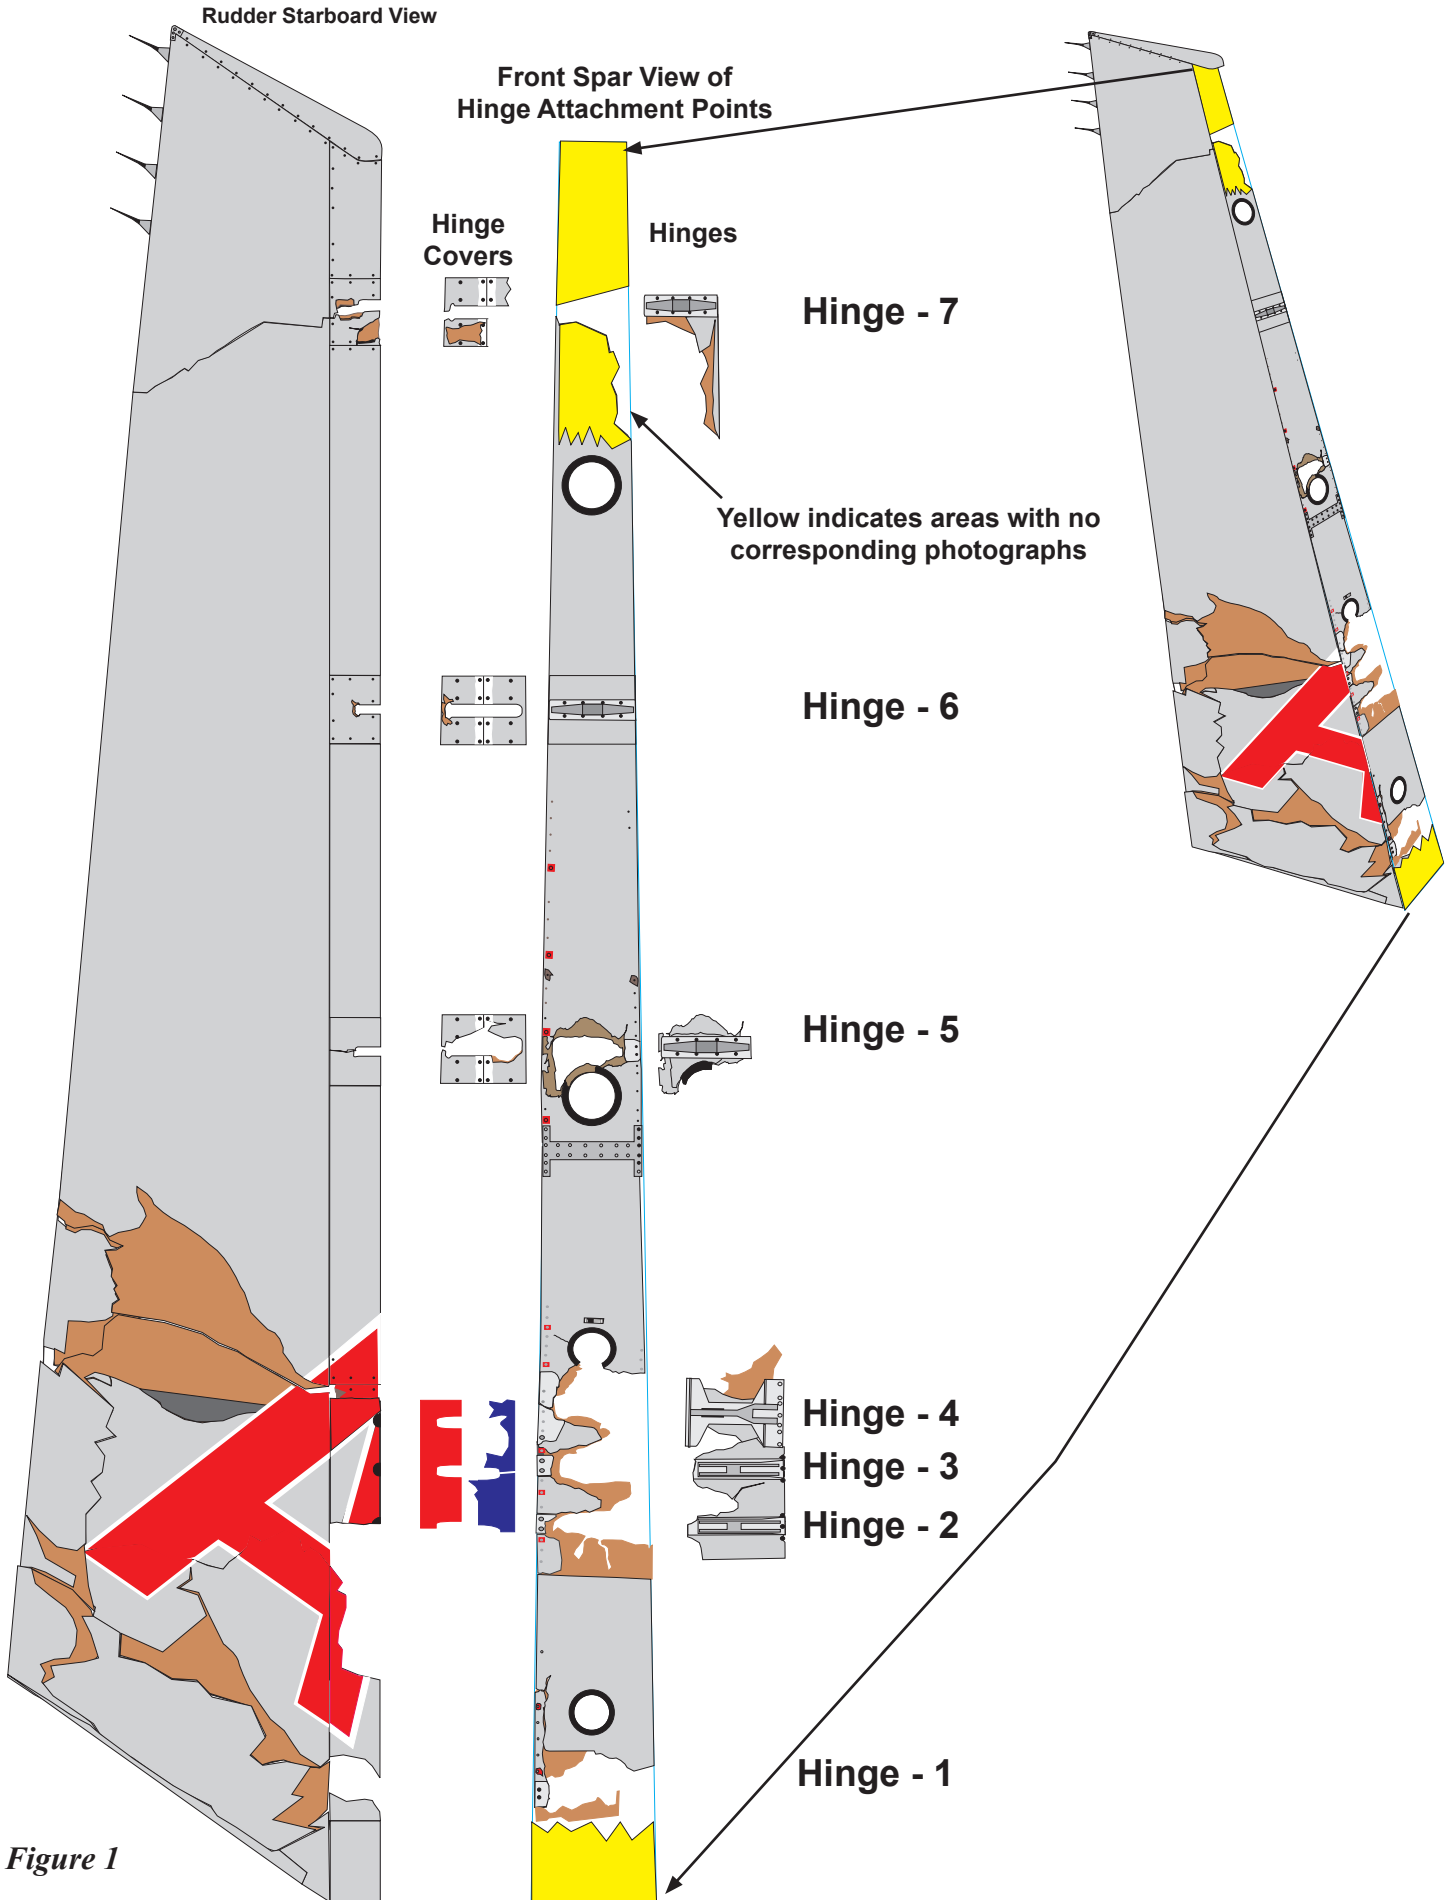
Figure 1

I believe the rudder failed initially at the top and then broke sequentially top down at or near the hinge attachment points.

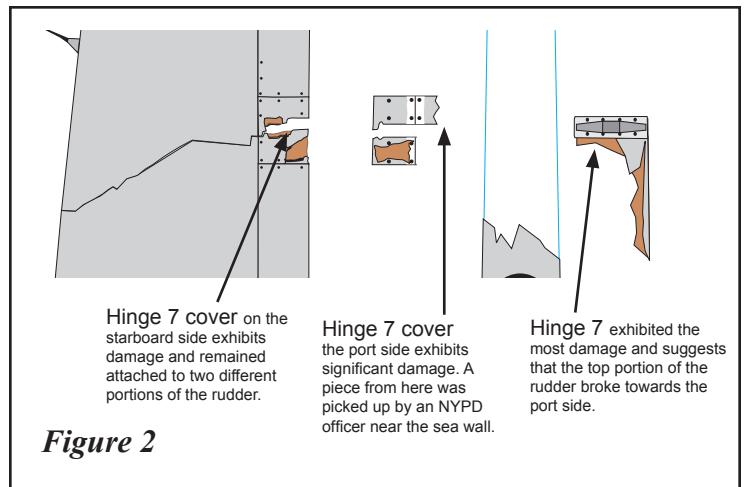
Figure 2

Approximately 4 feet of rudder extends above last attachment point, hinge 7.

Top of rudder breaks starboard to port and is torn away, leading edge rotating up and back.

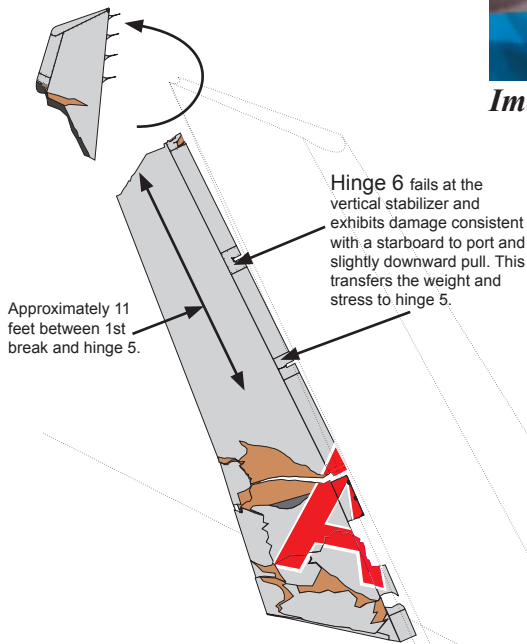
Figure 5

When hinge 6 failed all the stress and weight of the top portion of rudder was transferred to hinge 5 about 11 feet below the first break at hinge 1, (figure 5).

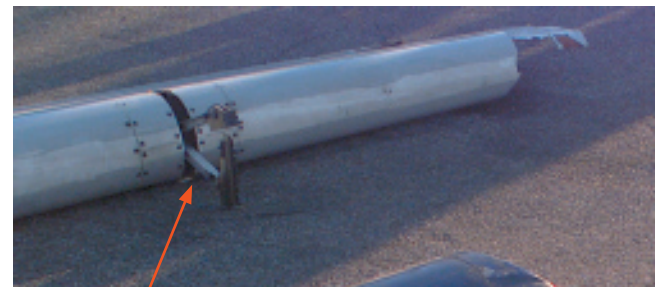
Image 6 Photo, Michael Hvozda, USCG

Hinge 5 is the lower hinge of the largest piece of the rudder. The hinge cover (*image 6*) exhibits the same port side damage seen in the actuator hinges. The damage to the hinge (*image 7*) itself and the attachment point seem to imply a top down tearing (*figure 6*), with a port twisting. I think it failed in a downward motion and is pulled through the port side of the hinge cover as the rudder section pivots backwards.

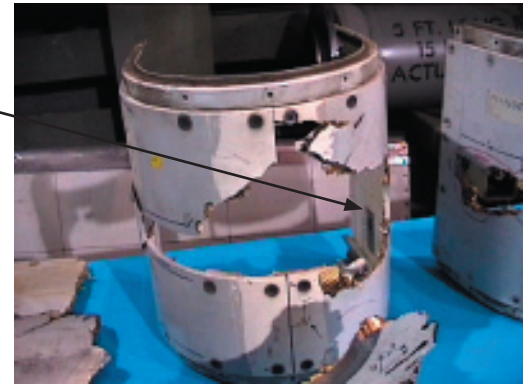
Image 6 Photo, US Read

Hinge 5 cover exhibits extensive port side damage.

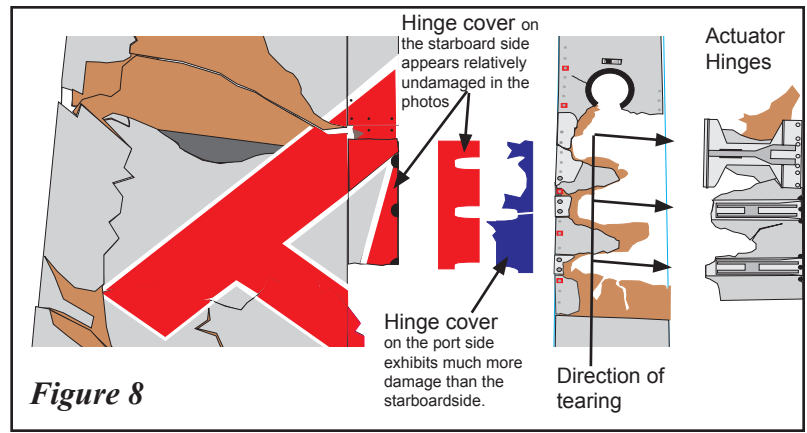
Figure 8

The area around the actuator hinges exhibits the most damage to the rudder. The same tearing left to right as seen around hinge 1 can be seen here. Photos of the port side actuator hinge cover shows considerable damage. This would indicate that when the actuator rudder hinges separated they tore through the hinge cover toward the port side.

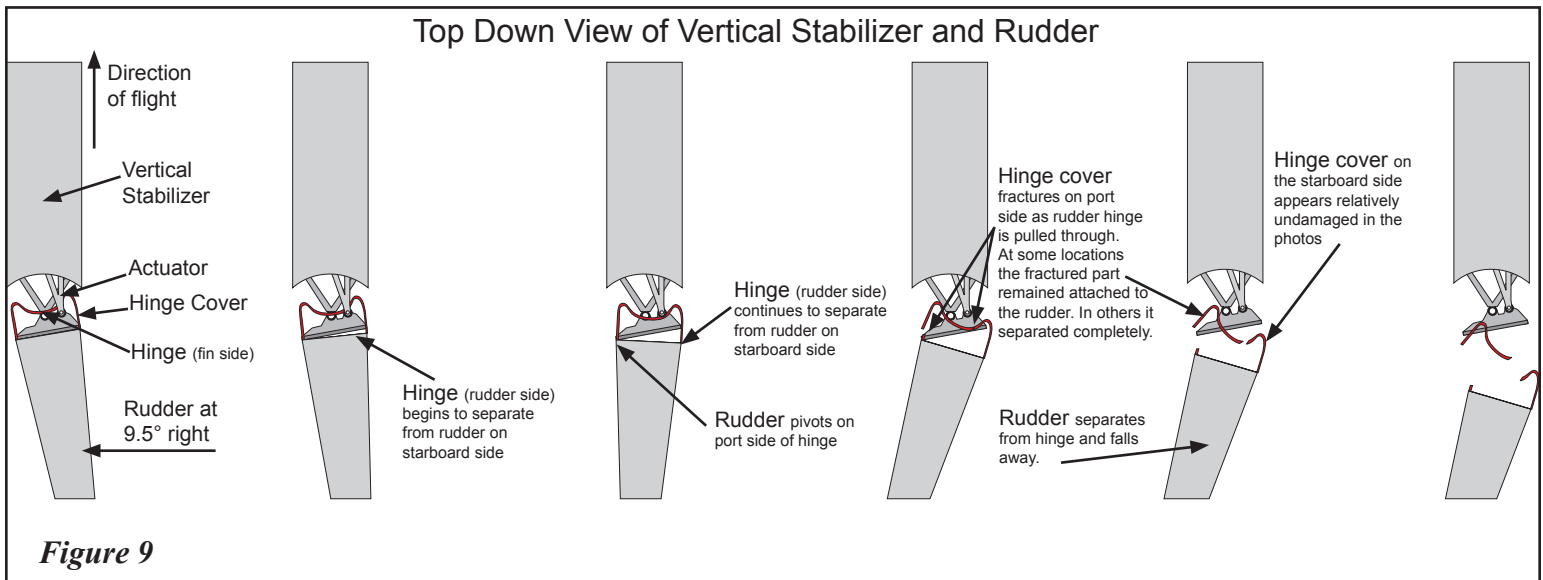
Figure 9

From photographs it can be seen that most of the rudder hinges remained attached to vertical stabilizer after the rudder broke. If the actuators remained in the 9.5° starboard position I interpret the separation of the actuator hinges as seen in (figure 9).

Actuator hinges placed in photo for illustration purposes.

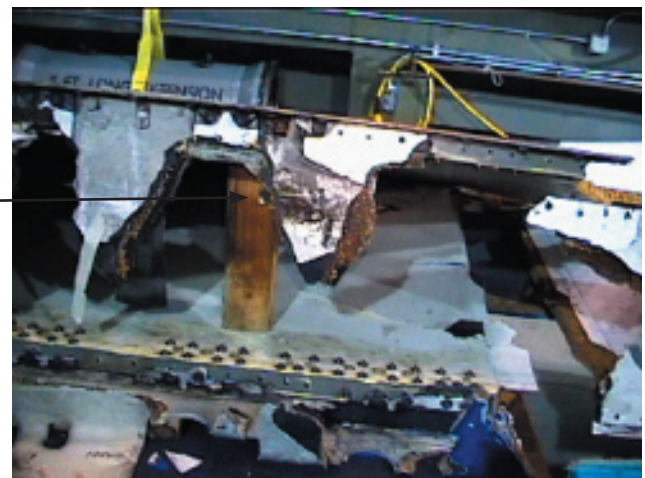
Image 8

A top down tearing would seem possible when viewed in light of the damage to the trailing edge near the base of the rudder (*figure 7 & image 8*).

Trailing edge damage suggests the top portion of the rudder section pivots backwards and twists starboard to port. This strip of metal from the port side trailing edge suggests this pattern of failure as does the loss of the laminate layer here.

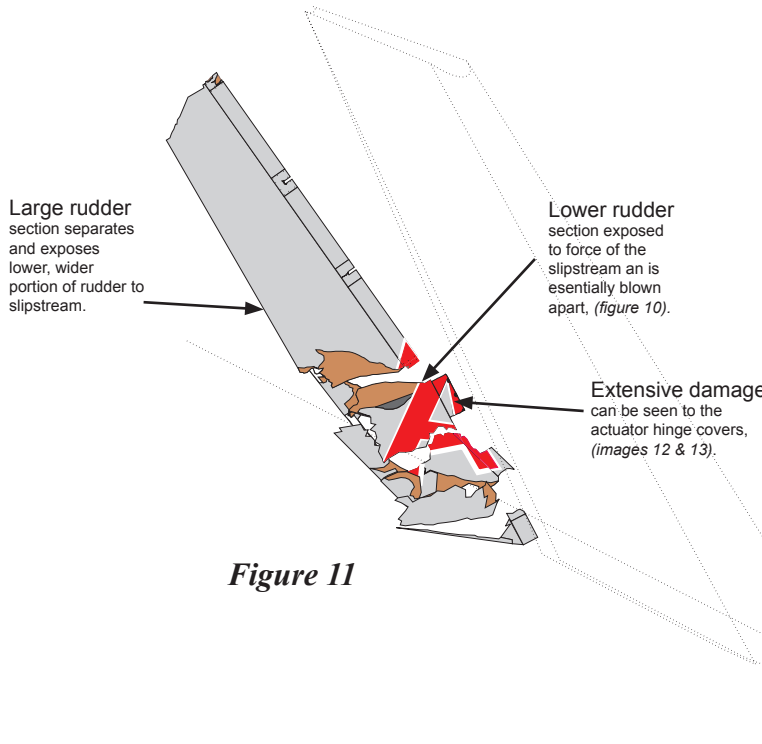
Figure 11

Trailing edge damage suggests that the lower portion of the rudder was pulled apart. The starboard side shows triangular tears pulled inward suggesting that it was pulled away from the port side. The port side of the same area shows the rivets intact
